INSPECTION DEPARTMENT
DROPPED OBJECT CANOPY INSPECTION
DATE: 07.11.11

INSPECTION REPORT

DROPPED OBJECT CANOPY (OUTER CANOPY CABLES & DAMPERS)				
DAMPNER PRESSURES TO BE SET AT 15-20 BAR, RAMS EXTENDED 20-30mm WIRE ROPES IN GOOD CONDITION, ANCHORAGES SECURE				
NO. 1 NEAREST TOWER	PRESSURE	EXTENSION	DEFECT	COMMENTS
DAMPNER/CABLE NO.1 SOUTH	40 Bar	28 mm	None	
DAMPNER/CABLE NO.2 SOUTH	40 Bar	42 mm	None	
DAMPNER/CABLE NO.3 SOUTH	40 Bar	42 mm	None	
DAMPNER/CABLE NO.4 SOUTH	40 Bar	43 mm	None	
DAMPNER/CABLE NO.5 SOUTH	40 Bar	46 mm	None	
DAMPNER/CABLE NO.6 SOUTH	45 Bar	42 mm	None	
DAMPNER/CABLE NO.7 SOUTH	38 Bar	28 mm	None	
DAMPNER/CABLE NO.8 SOUTH	38 Bar	28 mm	None	
DAMPNER/CABLE NO.9 SOUTH	38 Bar	27 mm	None	
DAMPNER/CABLE NO.10 SOUTH	30 Bar	105 mm	None	
DAMPNER /CABLE NO.11 SOUTH	40 Bar	43 mm	None	
DAMPNER/CABLE NO. 12 SOUTH	35 Bar	46 mm	None	
DAMPNER/CABLE NO. 13 SOUTH	40 Bar	43 mm	None	
DAMPNER/CABLE NO. 14 SOUTH	35 Bar	28 mm	None	
DAMPNER/CABLE NO. 15 SOUTH	30 Bar	110 mm	None	
DAMPNER/CABLE NO. 16 SOUTH	40 Bar	142 mm	None

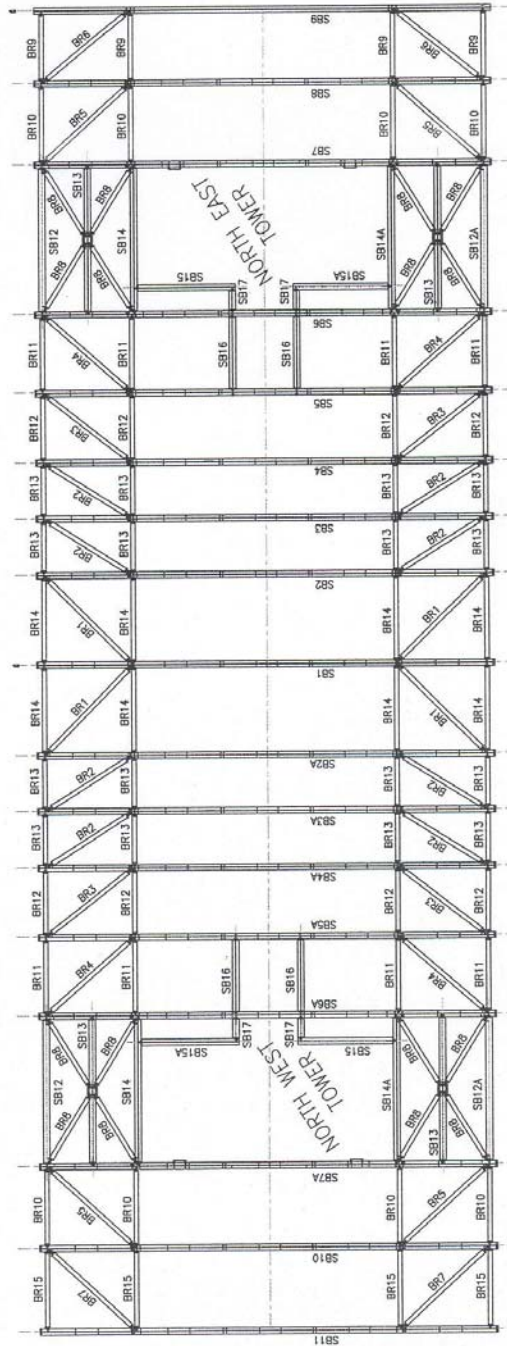
AS BUILT

Client:	FORTH ESTUARY TRANSPORT AUTH.
Project:	Dropped Object Canopy
Title:	Platform Deck Components
Date:	06/01/2006
Drawn:	D.L.A.
Drawn:	FOR/PCL/041
Drawn:	FOR

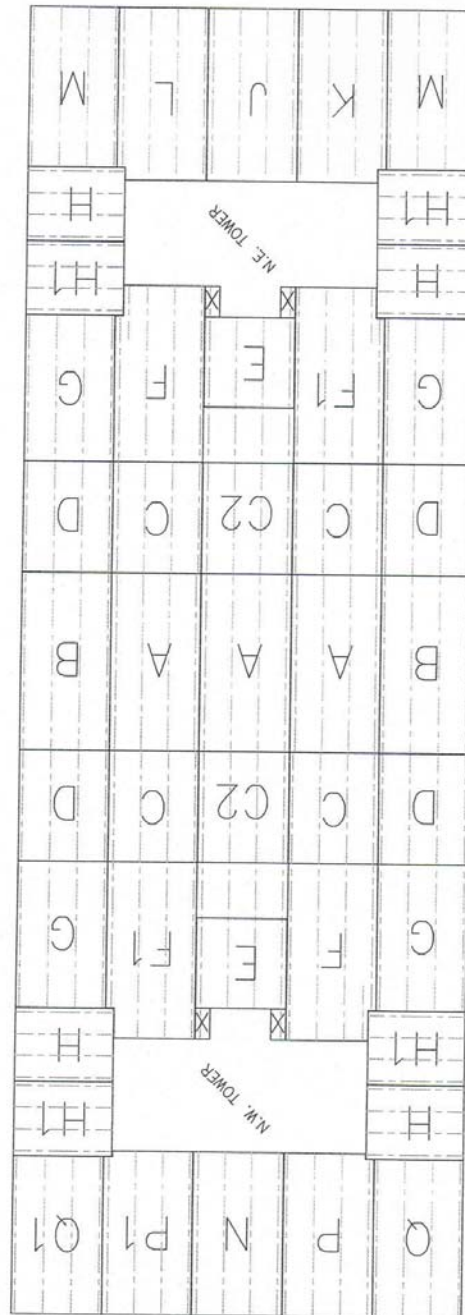
DECK PANELS: GENERAL ARRANGEMENT

AS BUILT

Client:	FORTH ESTUARY TRANSPORT AUTH.
Project:	Dropped Object Canopy
Title:	G.A. DECK PANELS
Date:	06/01/2006
Drawn:	B.L.A.
Rev:	
Doc Ref:	FOR1/PCL/100

DROPPED OBJECT CANOPY INSPECTION (DECK AREA)		
N.E. DECK AREA	DEFECT	COMMENTS
PANEL M	None	Satisfactory Water staining evident on underside of
PANEL L	None	" boards throughout
PANEL J	None	" "
PANEL H1	None	"
PANEL H	None	" "
PANEL G	None	"
PANEL F	None	" "
PANEL D	None	"
PANEL C	None	" "
PANEL C2	None	"
PANEL E	None	" "
PANEL B	None	"
PANEL A N	None	" "
PANEL A S	None	"
HANDRAILS/KICKPLATES	None	Satisfactory Paint breakdown evident – wear and tear evident
NONSLIP COATING	None	Satisfactory
FILLET STRIPS	None	Satisfactory
S.E. DECK AREA	DEFECT	COMMENTS
PANEL M	None	Satisfactory Water staining evident on underside of
PANEL K	None	" boards throughout
PANEL J	None	" "
PANEL H1	None	"
PANEL H	None	" "
PANEL G	None	"
PANEL F1	None	" "
PANEL E	None	"
PANEL D	None	" "
PANEL C	None	"
PANEL C2	None	" "
PANEL B	None	"
PANEL A N	None	" "
PANEL A S	None	"
HANDRAILS/KICKPLATES	None	Satisfactory Paint breakdown evident – wear and tear evident
