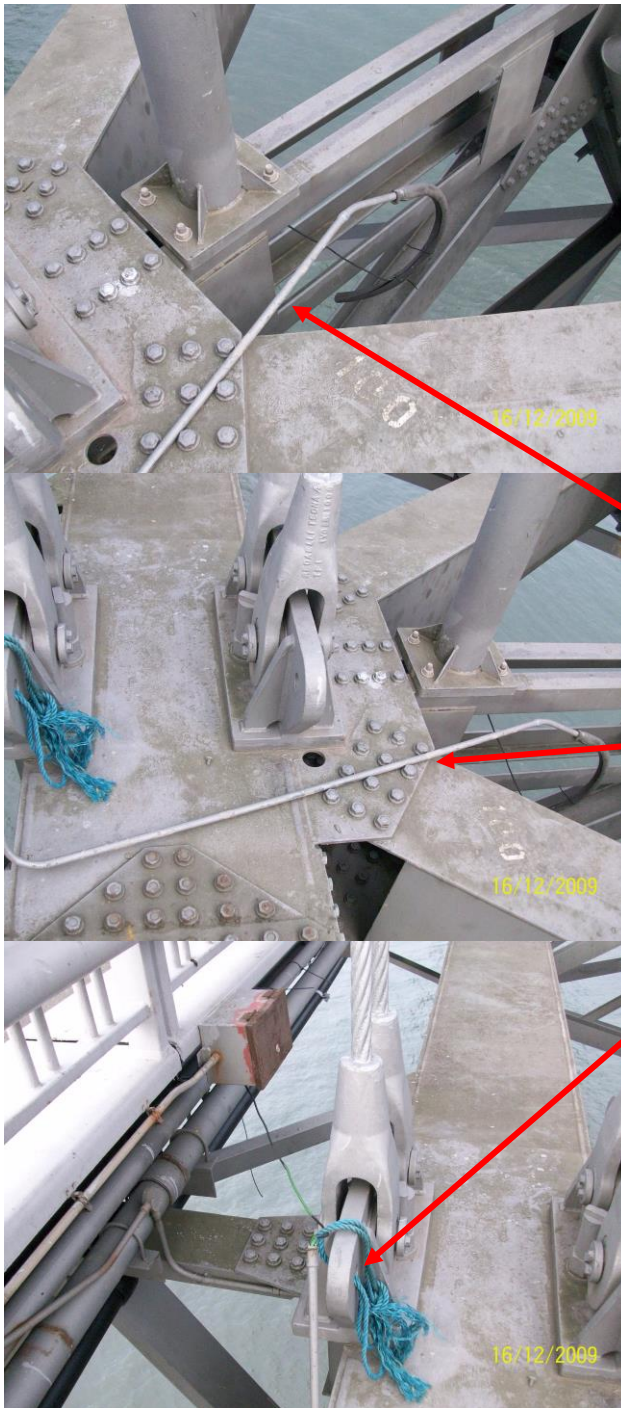
P.P. 100 N.W.

ANEMOMETER CONDUIT AND
CABLE REQUIRES PROPER
SECURING, OR REMOVAL IF
REDUNDANT.
