INSPECTION DEPARTMENT

FORTH ROAD BRIDGE

Combe plate weekly survey sheet DATE. 2015.03.02

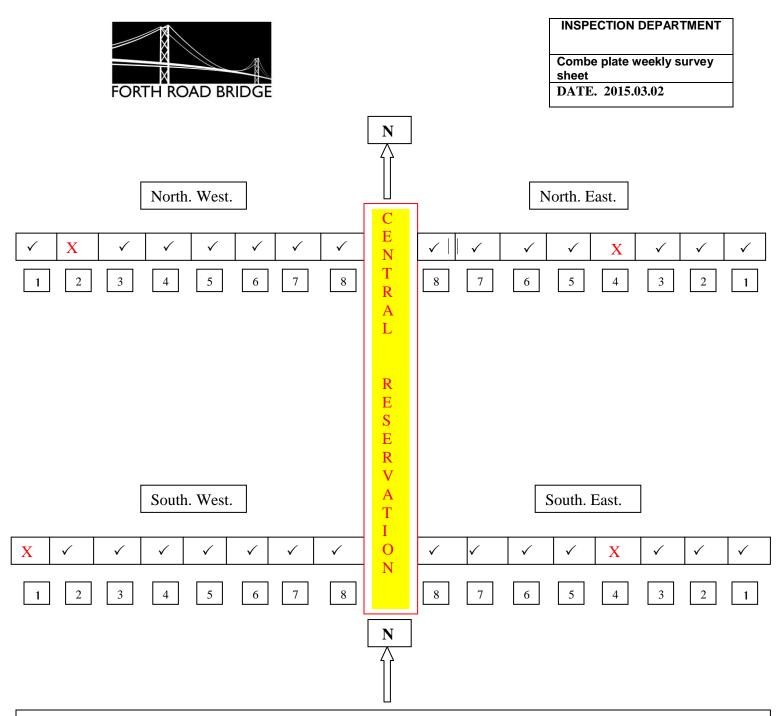
On the Northbound Carriageway (West Side) NW2 – movement/noise evident when heavy vehicles pass over On the Southbound Carriageway NE4 – movement/noise evident when heavy vehicles pass over

On the Northbound Carriageway (West Side) SW1 – repair previously carried out 06.01.15 by Engineers – noise was still evident on east side of SW1 - spring packs replaced on SW1 and SW2, further works to be carried out On the Southbound Carriageway SE4 – movement/noise evident when heavy vehicles pass over Southbound Carriageway SE2 – there is slight movement on the west side.
