P.P.95 – 96 N.W.

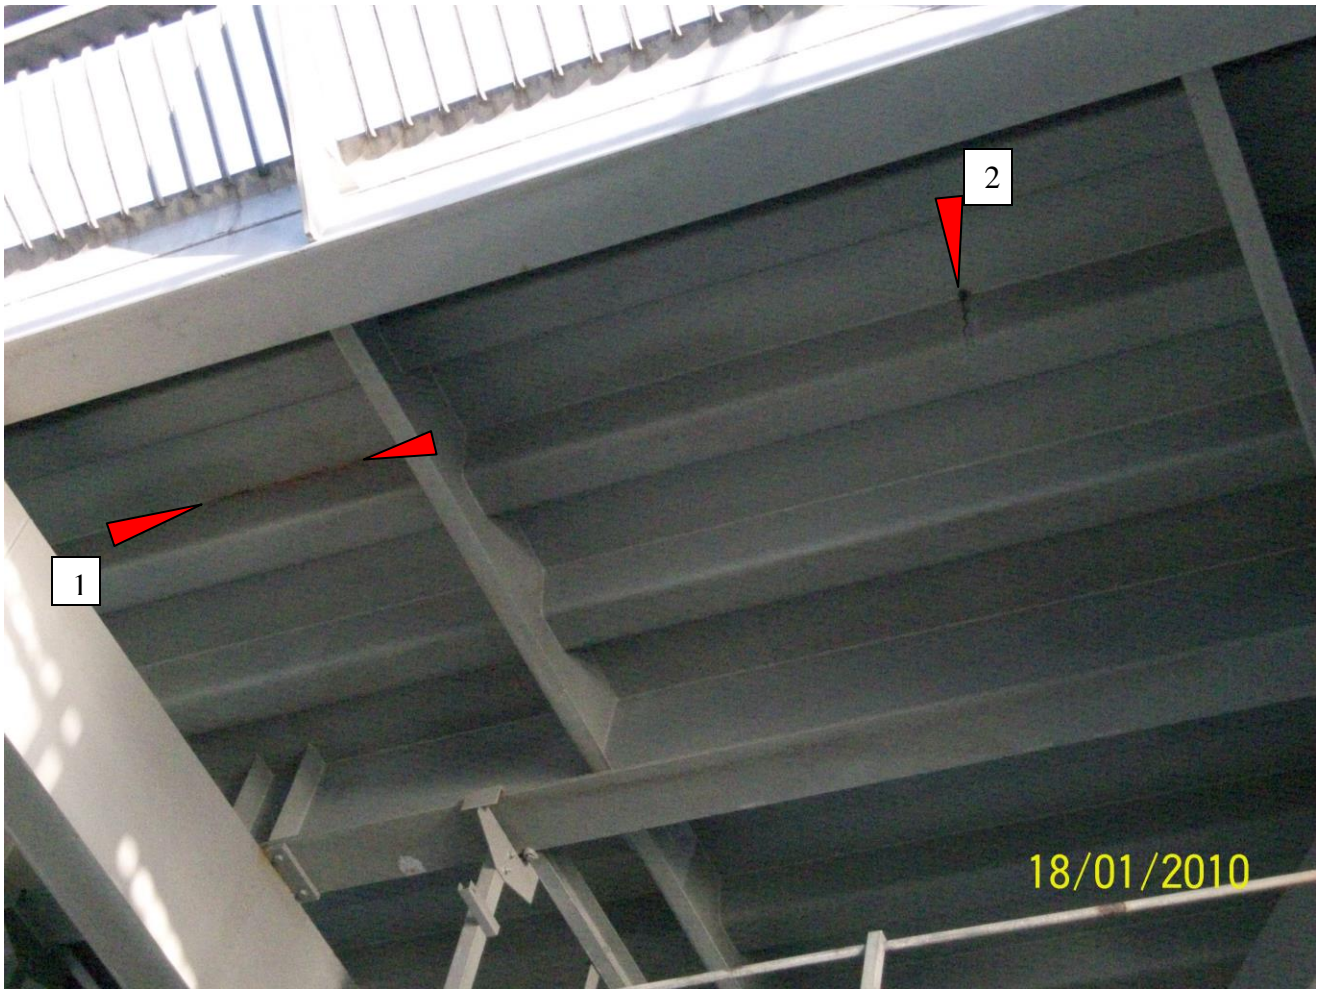
1. Longitudinal crack approx. 600mm long.
2. Potential new crack start point, unable to determine without closer inspection.
Ensure staging is large enough to encompass No. 2 potential defect.
